**Inspection Order No. :** IN-TJ-5301-10086-02

**INDEPENDENT QUALITY CONTROL REPORT**

- Description and Quantity of Commodity:** ERW steel pipes/ 3205pcs/for other details see the attached
- Name & Address Of Buyer:**

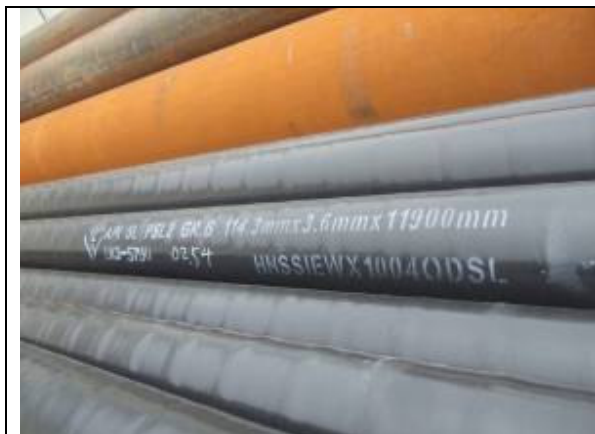
Marking check

Below marking was painted on the pipes:

<API logo>**API 5L PSL2 GR.B** (or X 42) \*\*\*mm (outer diameter) **X\*\*\*** (wall thickness) **mmX11900mm**  
 \*\*\* (heat no.) \*\*\* (pipe no.) **HNSSIEWx10040DSL**

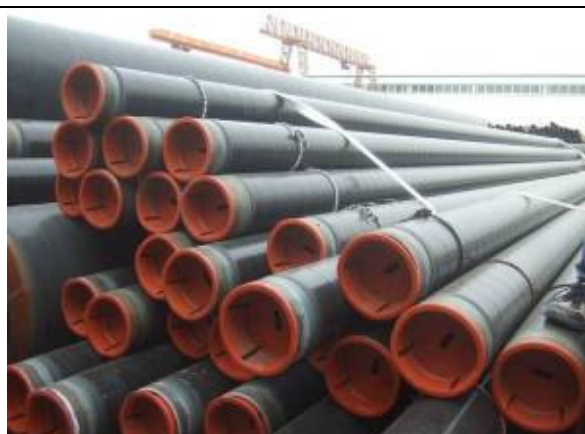
Packing check

The pipes were packed in bundle.
